# E-6 Flutter Investigation and Experience

Robert G. Borst\* and Robert W. Stromet

Boeing Defense & Space Group, Electronics Systems Division, Air Vehicle Technology  
Seattle, Washington

During E-6 airplane flutter testing, two separate incidents occurred which resulted in the partial loss of aircraft vertical tails. In both cases, the aircraft landed without further incident. Linear aero-servo-elastic analyses provided no indication of a flutter instability. Non-linear aero-servo-elastic behavior had to be included to define the instability. Resolution involved gain stabilizing the rudder control system and phase stabilizing the vertical fin structure. Analytical and test results leading to resolution of E-6 aero-servo-elastic flutter are presented. Attention is focused on the multidisciplinary interaction of aerodynamics, flight controls, and structures.

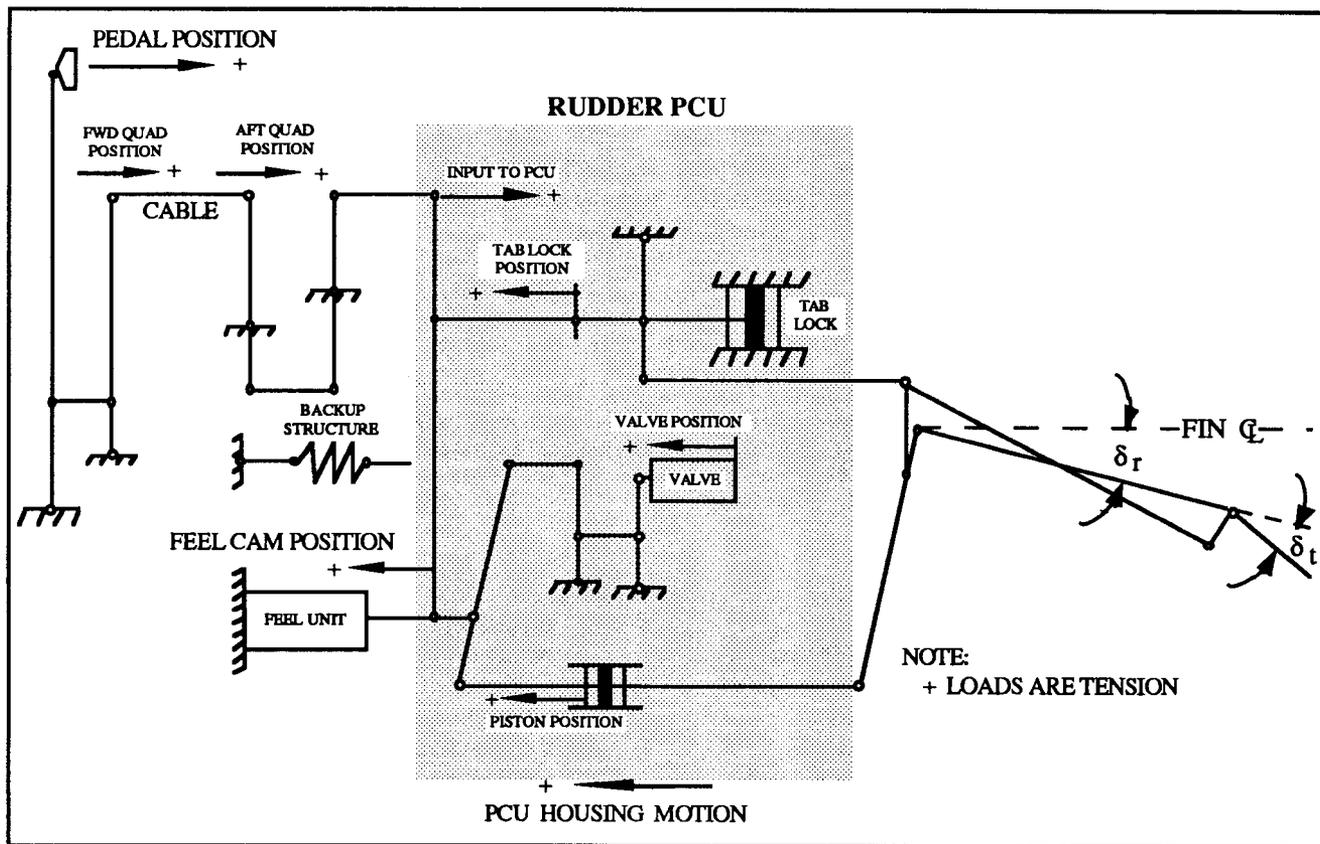
Fig. 1 Schematic of The E-6 Rudder Control System

Fig. 1 shows a schematic of the E-6 rudder control system which includes the rudder pedals, forward quadrant, cables, aft quadrant, feel unit, rudder Power Control Unit (PCU), rudder, and tab. Rudder boost pressure is supplied by the auxiliary hydraulic system. The rudder is controlled by conventional rudder pedals, hinged for toe operation of the hydraulic brakes. Movement of the pedals is transmitted by cable and linkage to the valve of the rudder PCU, located in the vertical fin, which deflects the rudder. During powered operation, the tab linkage is hydraulically locked at the rudder PCU and the tab moves in the same direction as the rudder. Artificial feel is provided in proportion to rudder deflection and airspeed. Artificial feel is derived from a spring mechanism wherein the stiffness is modified by a dynamic air pressure linkage (q-bellows).

The E-6 rudder control system also has manual reversion capability. If hydraulic pressure fails or is turned off, the rudder automatically shifts to tab control. The rudder control tab is unlocked and pedal motion operates the control tab to move the rudder assisted by aerodynamic balance panels. In this case, the tab moves opposite to the rudder. Maximum rudder deflection is about one-half and

pedal pressure is double the powered configuration for any given control effect.

Two analysis formulations of the rudder control system shown in Fig. 1 were developed. A linear transfer function representation was used for frequency domain flutter analyses and time domain simulation. A non-linear physical representation was used for time domain simulation and experimentation.<sup>3</sup> Both rudder control system formulations were validated by back driving the models with test measured rudder pedal force, rudder rod load, and tab rod load. There was good agreement between analysis model displacements and test measured displacements. The rudder control system physical formulation is described in detail in the integrated aero-servo-elastic flutter model section of this paper.

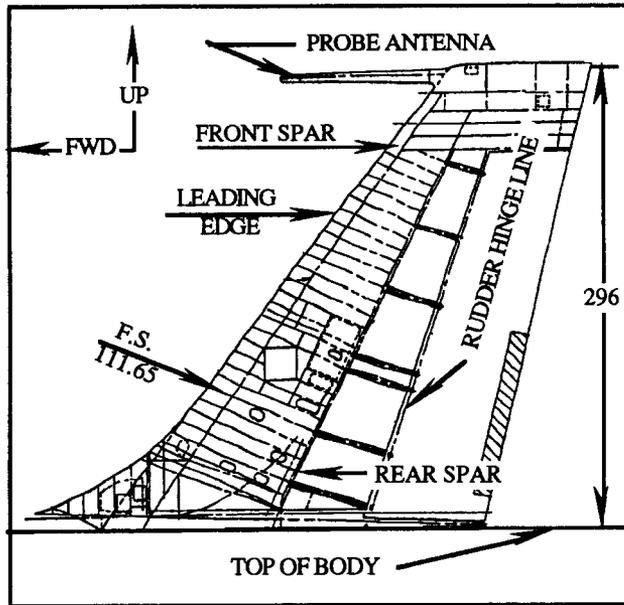
Fig. 2 Fin Structural Layout

The fin primary structure is a single cell, two spar box of aluminum skin panels supported by ribs running fore and aft between spars. The fin is attached to the fuselage structure by four terminal end fittings. The front spar web is not continuous and ends at Fin Station 111.65 (Fig. 2). Above Fin Station 111.65, the fin box consists of the rear

spar web, skin panels, and the leading edge. The leading edge is attached to the box at the front spar chords. The joint at this location has loose tolerance holes so that the leading edge can be easily removed.

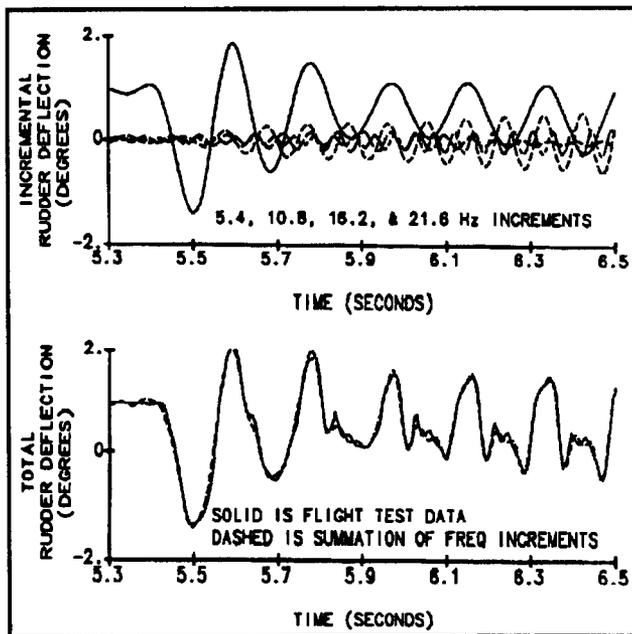
Fig. 3 Frequency Decomposition Of Sept. 28, 1989 Rudder Deflection Angle At PCU

A Fast Fourier Transform (FFT) routine<sup>1</sup> was used to calculate the Power Spectral Density (PSD) and hence, frequency content of the September 28, 1989, flight test data. As expected, the largest PSD for the majority of test measurements occurred at 5.4 Hertz. However, the largest PSD for longitudinal PCU support acceleration and longitudinal PCU housing acceleration was 10.8 Hertz. Other PSD peaks occurred at the harmonic frequencies of 16.2 and 21.6 Hertz. Once the frequency content of the data was determined, bandpass filters were designed to breakdown the flight test data into individual frequency components.<sup>2</sup> The bandpass filters used a FFT to convert the time domain flight test data to the frequency domain. The values of the transform within the desired pass band were multiplied by one. The values outside the pass band were multiplied by zero. This modified transform was then converted back to the time domain by the FFT routine. This technique resulted in extremely narrow width bandpass filters with minimal side lobe degradation. The bandpass filter technique was validated by summing the individual frequency components and comparing this summation to the original flight test data. Fig. 3 shows an example of this analysis for the September 28, 1989, flutter incident rudder deflection angle measurement. Fig. 3 also illustrates that superposition of the 5.4 and 10.8 Hertz components was responsible for the one-sided clipping seen in the flight test measurement.

The 10.8 Hertz frequency component observed in the September 28, 1989, flutter incident data is the result of two separate frequency doubling mechanisms: yaw rotation of the PCU housing and PCU dual concentric valve design. The PCU, which is mounted on back-up structure offset from the fin center line, rotates two cycles for every cycle of rudder deflection. The PCU dual concentric valve design characteristics cause the flow rate (and differential pressure across the PCU piston) to change direction twice for every cycle of rudder deflection. The low amplitude 16.2 and 21.6 Hertz frequency components, also observed in the flutter incident data, result from harmonic frequency summation of the 5.4 and 10.8 Hertz components. The break frequency ( $1/2\pi\tau$ ) of the E-6 PCU, represented by the Eq. (1) first order lag, is approximately 4.5 Hertz. Consequently, there is significant attenuation of frequency components greater than 5.4 Hertz from a PCU input to output displacement transfer function perspective. These high frequency components, however, are directly transmitted to the rudder via the PCU housing structure path.

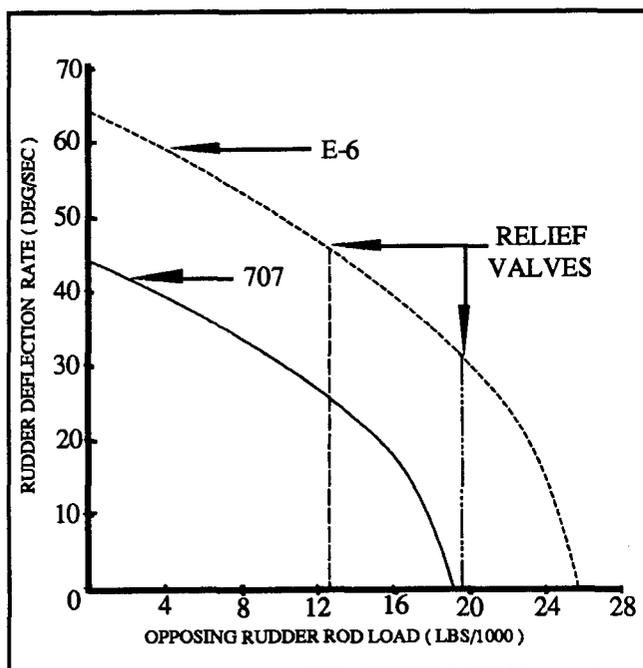
Fig. 4 E-6 & 707 Rudder Rate Characteristics

During E-6 powered operation, 3000 psi hydraulic supply pressure is available to the rudder PCU. For the E-6 rudder PCU, this equates to a no-load rudder rate of 64 deg/sec. The maximum differential pressure across the E-6 PCU piston is limited in two airspeed steps in order to prevent loads, due to rudder deflection, from exceeding

structural limits. Between 175 and 250 KIAS, the PCU piston differential pressure limit is set to 2250 psi. Above 250 KIAS, the PCU piston differential pressure limit is set to 1450 psi. An override switch can be used at any airspeed to restore the available piston differential pressure to full system supply pressure. Limiting PCU differential pressure has the effect of decreasing maximum available rudder angle without decreasing rudder rate capability.

In contrast, the 707 no-load rudder rate is 51 deg/sec at 3000 psi supply pressure. The 707 PCU supply pressure is reduced to 2250 psi above 250 KIAS. Reducing PCU supply pressure to 2250 psi has the effect of decreasing the maximum available rudder angle and decreasing the rudder rate capability to 44 deg/sec. Fig. 4 shows rudder rate as a function of opposing rudder rod load and illustrates the significant rate capability difference between E-6 and 707 aircraft.

Prior to the resumption of flight testing, the E-6 hydraulic system was modified to decrease the no-load rudder rate to levels similar to the 707 airplane (44 deg/sec). A pressure reducer was installed to limit the PCU supply pressure to 2250 psi. At 2250 psi supply pressure, the E-6 rudder rate was 55 deg/sec. A flow restrictor was installed to further reduce rudder rate. The net effect of both these modifications was to decrease the E-6 no-load rudder rate capability to 35 deg/sec.

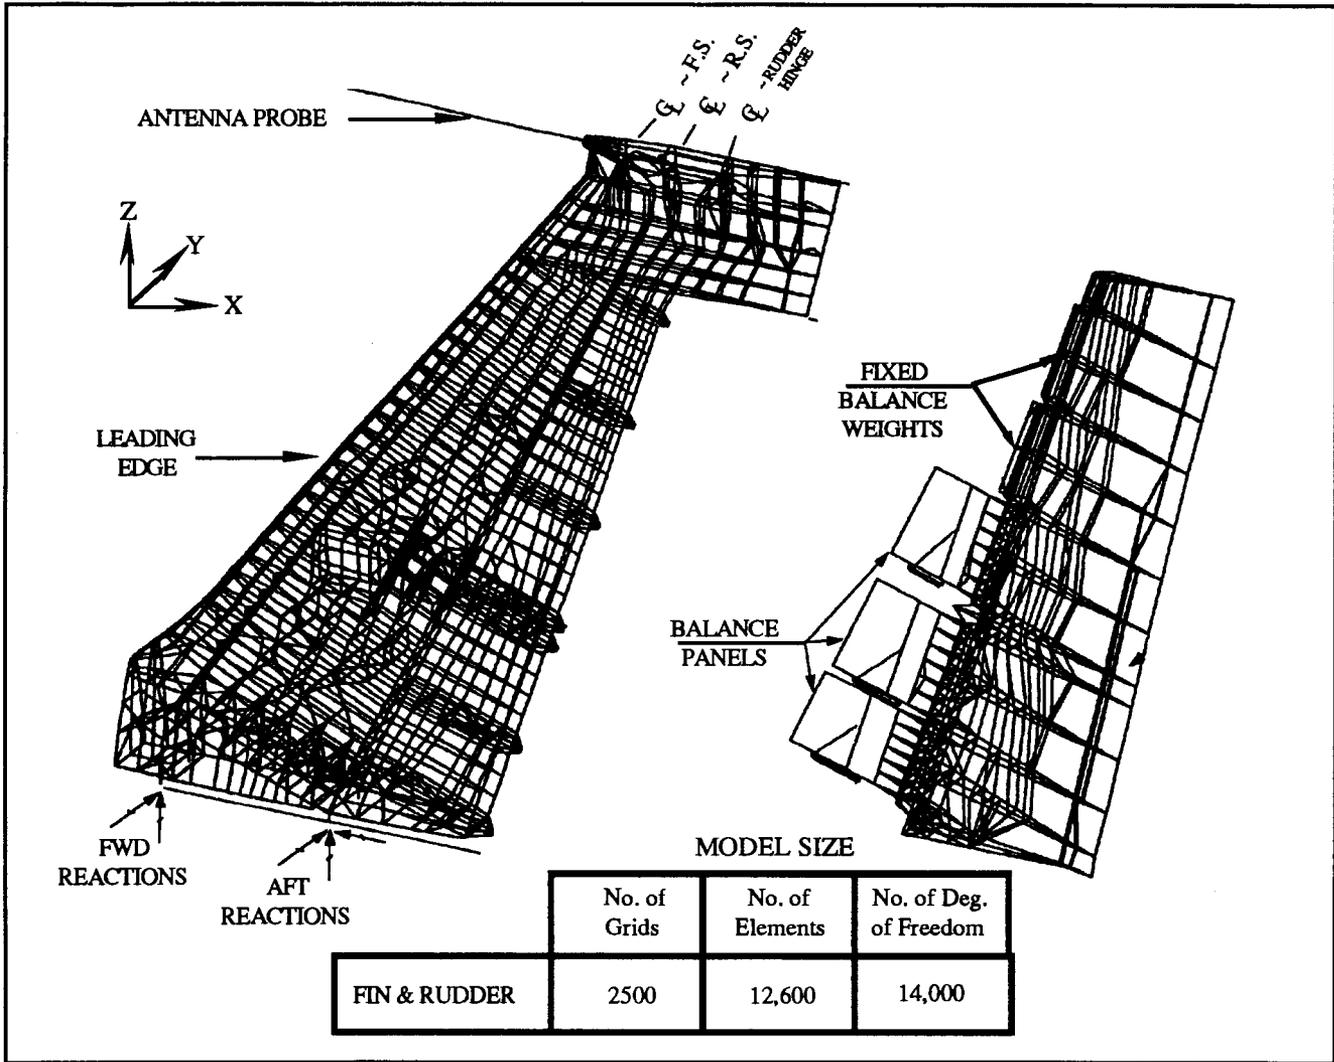
Fig. 5 E-6 Vertical Fin Nastran Finite Element Model

In order to obtain an accurate stiffness representation of the vertical fin for aero-servo-elastic flutter analysis, detailed finite element models of the fin and aft fuselage were built using the NASTRAN Finite Element Code.<sup>5,6</sup> The fin finite element model consisted of 2500 grids (14,000 degrees of freedom) and 12,600 elements (Fig. 5). The aft fuselage model had 700 grids and 4000 degrees of freedom. The fin model was validated by comparison with full-scale static and dynamic (modal) vertical fin test data.

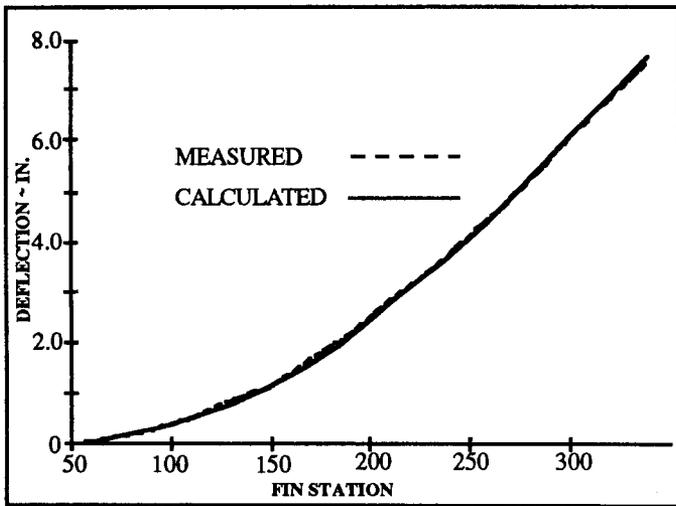
Fig. 6 Fin Static Deflection

A comparison between calculated and measured static deformation for a bending loadcase is shown in Fig. 6. Excellent correlation was obtained. Good correlation was also obtained with the other test loadcases (torsion and combined bending and torsion).

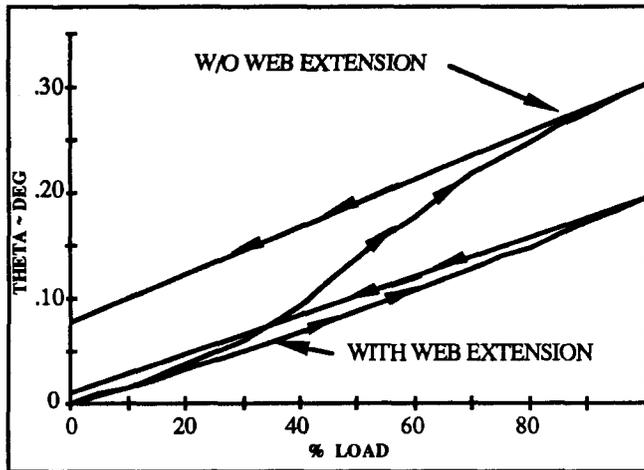
Fig. 8 Fin Torsional Deflection vs. Load (Twist Over 18in. Panel)

Structural behavior was as predicted by finite element and hand analysis except the fin exhibited non-linear behavior under certain loading conditions. When the applied torsion exceeded a certain level, fin twisting deformations increased dramatically (Fig 8). It was found that this occurred when the shear across the leading edge joint exceeded a certain level. Further investigation determined that this was not caused by buckling, but rather by slippage between the leading edge fairing and the front spar chords

which occurred when the frictional forces due to fastener preload were overcome. Slippage occurred until the gaps between the fasteners and the edges of the holes were closed. The leading edge joint detail is shown in Fig. 9. During repeated loadings in the same direction, the slip effect was reduced since the fasteners were already bearing on the edge of the holes. The slip behavior was found to be repeatable after removing and replacing the leading edge.

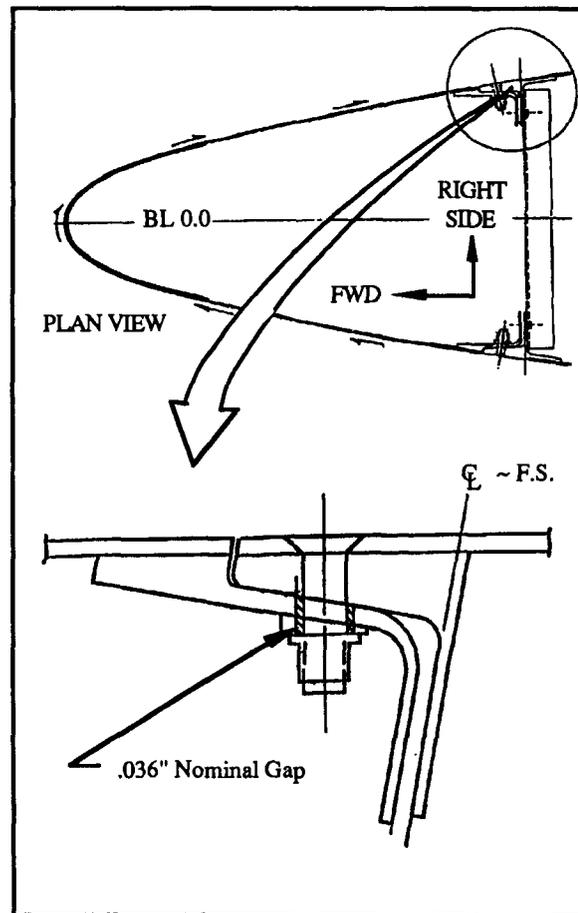
Fig. 9 Vertical Stabilizer Leading Edge Installation

As a result of test and analysis, which showed the slip mechanism to be a possible contributor to fin flutter, a front spar web was added above Fin Station 111.65 to ensure that fin torsional stiffness would be maintained without relying on leading edge fairing friction for shear flow transmission. Subsequent static and dynamic testing with the web extension installed confirmed that this design change maintained torsional stiffness and prevented slip. Static test results are shown in Fig. 8. Dynamic test results for the tip twist mode are shown in Fig. 10. When the leading edge was loosened, with the web extension installed, there was negligible change in frequency.

to be due to degradation of the stiffness of the antenna probe base support in the fin tip. Inspection and testing showed that the fiberglass probe base had been damaged by dynamic testing of the fin. This occurred between the time when the original dynamic test was run and when the test was re-run with the web extension installed. This degradation was attributed to the large number of cycles applied to the fin during this interim period. This environment was much more severe than would ever be encountered in actual service. This data along with the finite element analysis gave confidence that the web extension would prevent slip and improve flutter characteristics.

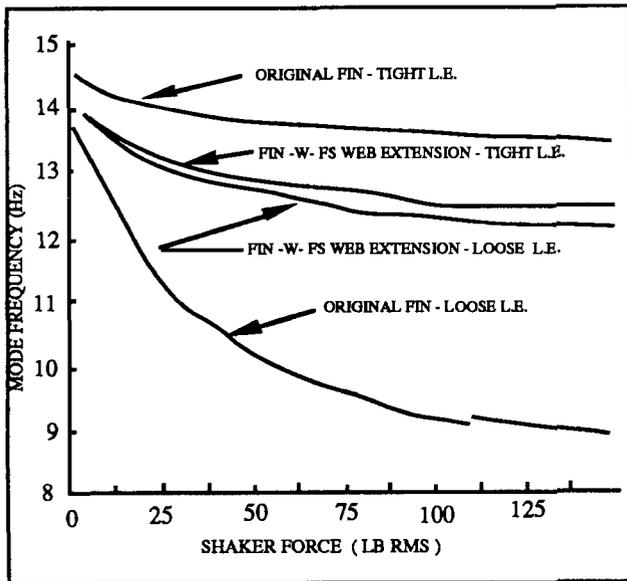
Fig. 10 Tip Twist Mode Frequency vs. Input Force

The apparent tip twist frequency decrease of 8-10%, with the web extension installed (Fig. 10), was determined

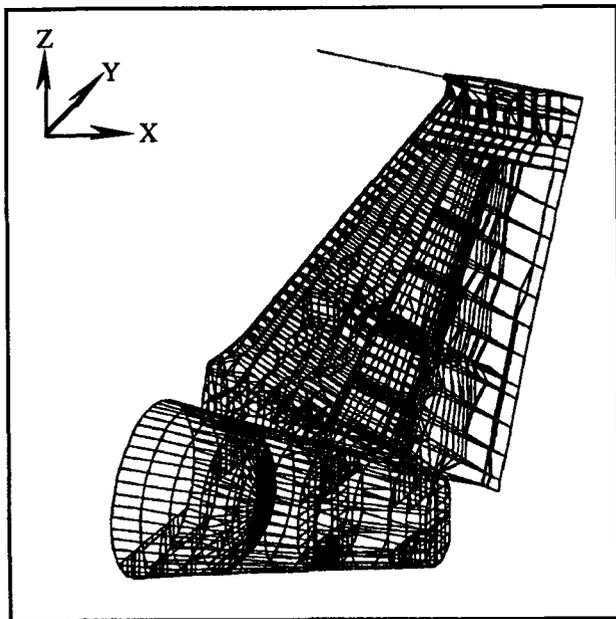
Fig. 11 Nastran Fin, Rudder, And Section 48 FEM Model

The validated NASTRAN model of the vertical fin was reduced to approximately 250 degrees of freedom for use in aero-servo-elastic flutter analyses. This model was merged with another NASTRAN model of Section 48 (Fig. 11) and a "stick" model representation of the remaining airplane. The models were merged using component mode

synthesis techniques. Degrees of freedom were provided in the fin model to permit merging of the rudder control system. Linear aero-servo-elastic flutter analyses performed with this model correlated fairly well with

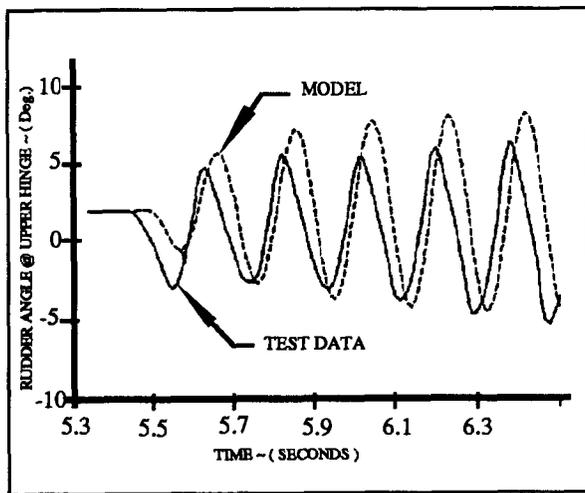
**Fig. 12 Approximation Of Effect Of Non - Linear Structure On Rudder Angle @ Upper Hinge**

It is necessary to include the effect of non-linear fin structure leading edge slip behavior in order to induce instability in the analysis model. The Eq. (33) transfer function calculates the upper rudder hinge deflection angle relative to fin structure with an approximation of the effect of fin leading edge slip. The intent of Eq. (33) is to introduce 70 degrees of phase lag between the two rudder deflection angles as observed during the September 28, 1989 incident. Fig. 12 shows the results of this approximation;

the September 28, 1989, flutter incident upper hinge rudder deflection angle is compared with the Eq. (33) result. Eliminating fin leading edge slip effectively phase stabilized the E-6 aero-servo-elastic flutter system.

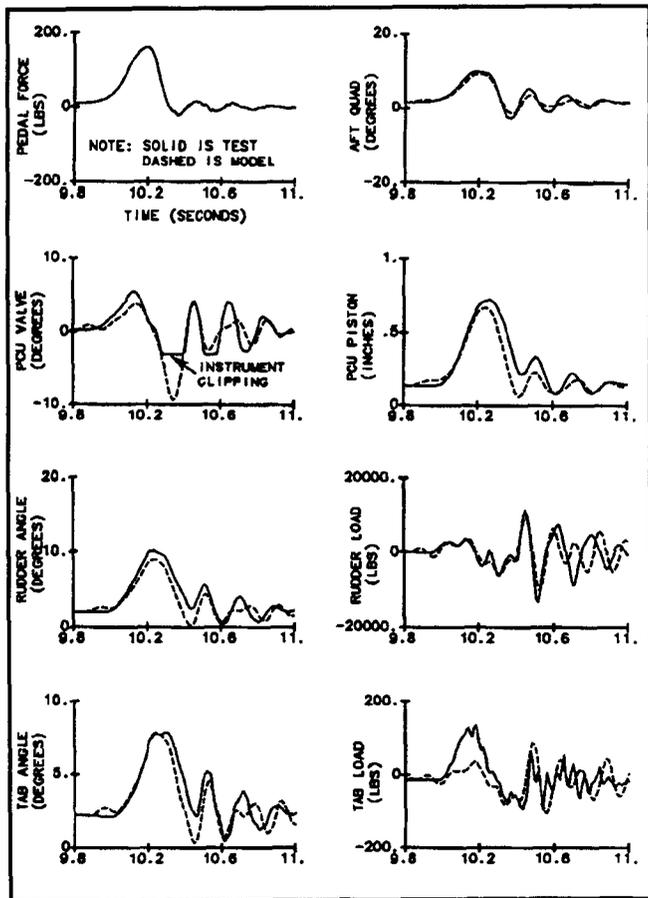
**Fig. 13 Servo - Elastic Model Correlation With Ground Test Data**

Fig. 13 shows ground test data and simplified servo-elastic analysis model correlation. Note that the rudder rod

load is always 180 degrees out of phase with the rudder deflection angle. The analysis model is significantly less damped with the rudder and tab aerodynamic stiffness terms set to zero. The analysis model damping increases significantly if the rudder and tab mass terms are then set to zero (i.e., rudder and tab removed). This agrees with previous rudder control system analyses and laboratory test results.

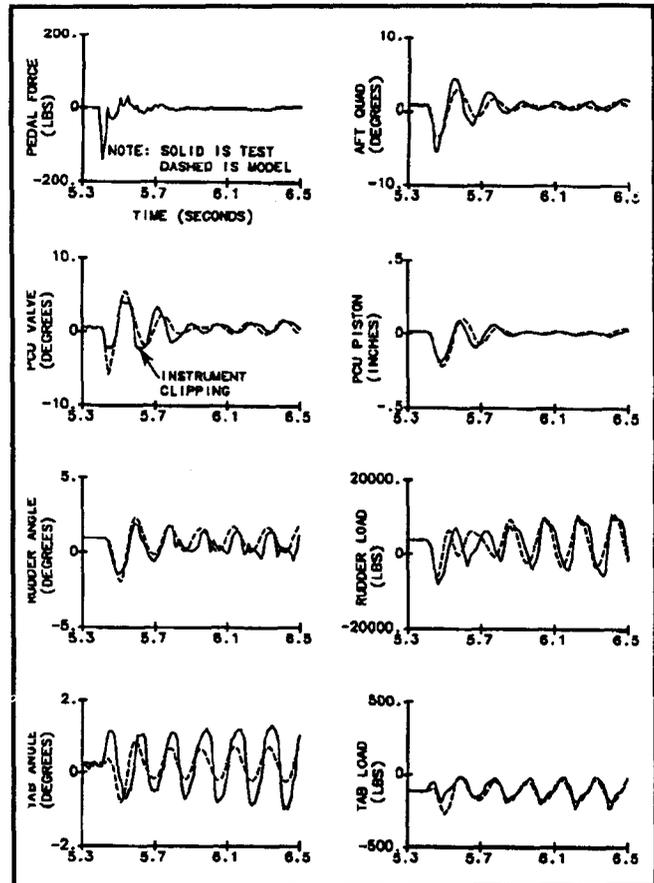
**Fig. 14 Aero - Servo - Elastic Flutter Model Correlation to Sept. 28, 1989 Flutter Incident Data**

Fig. 14 shows the September 28, 1989, flutter incident flight test data and simplified aero-servo-elastic flutter analysis model correlation. Note that the rudder rod load and rudder deflection angle are initially in phase and then transition to a 180 degree out of phase condition.

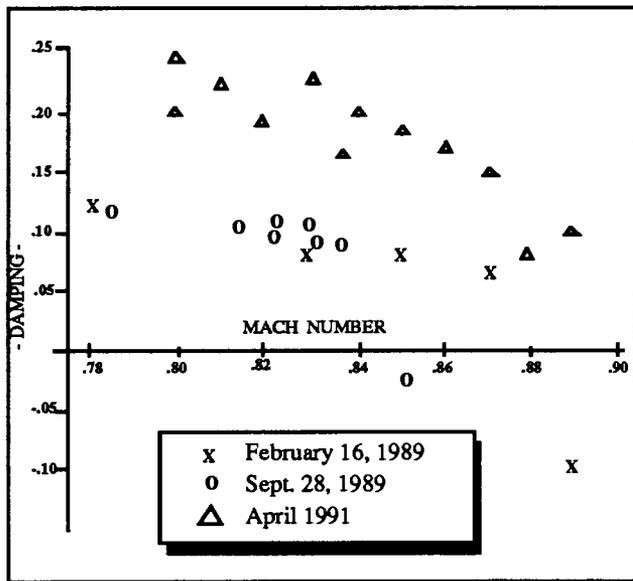
Fig. 15 E-6 Fin Damping @ 15,000 ft.

The flutter flight test program was conducted in four distinct airspeed phases to minimize risk as the flight envelop was expanded. Rudder control system modifications were evaluated during initial flutter flight test phases. Sufficient time was provided between successive phases to permit detailed flight test data analyses. The final rudder control system configuration was selected prior to the last flutter flight test phase and included the PCU supply pressure reducer and flow rate restrictor. The final flutter flight test confirmed adequate damping at critical airspeeds and altitudes as shown in Fig. 15. Fig. 16 shows the successful April 16, 1991, flutter test data and simplified aero-servo-elastic flutter analysis model correlation with final modifications included.
